Manhole Inspection Summary

Manhole # S51GG_007MH

Insp Date: **6/9/08 8:05 AM**

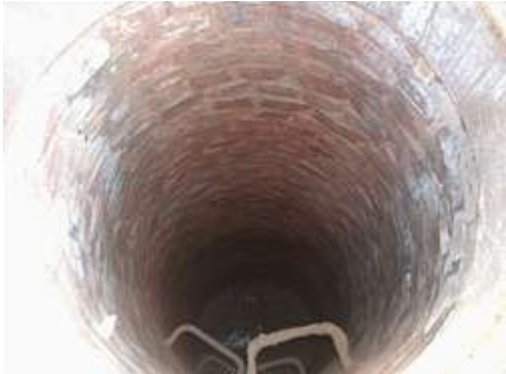
Defect 1

☒ **Leaks**

frame leaks

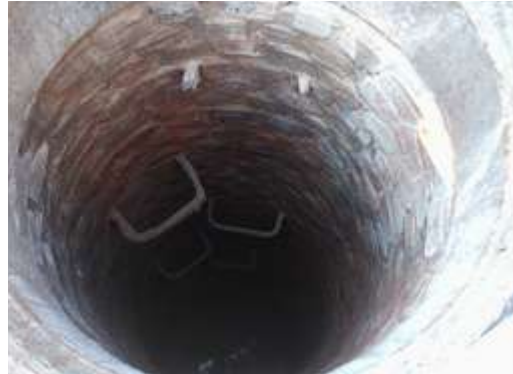
Defect 2

Steps Count: **11** Missing: **1** ☒ **Corroded**

broken step
